Manhole Inspection Summary

Manhole # S17II1002MH

Insp Date: **1/11/07 9:14 AM**

Location Address: **2303 DERBY RD**

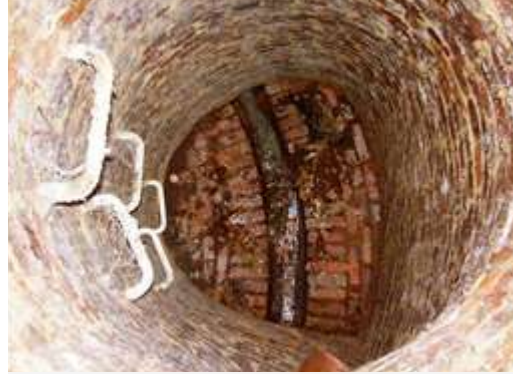
Top View

Adjustment infiltration. Corbel deterioration and infiltration. Corroded steps. Evidence of surcharge - Bench

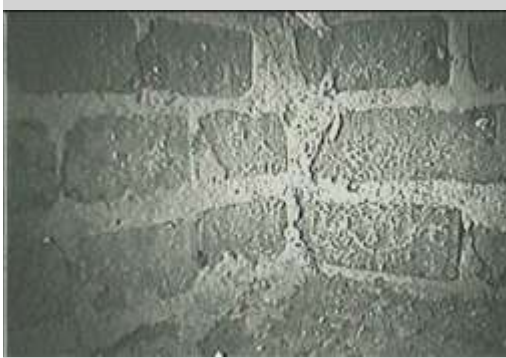
Defect

Barrel root intrusion and infiltration.

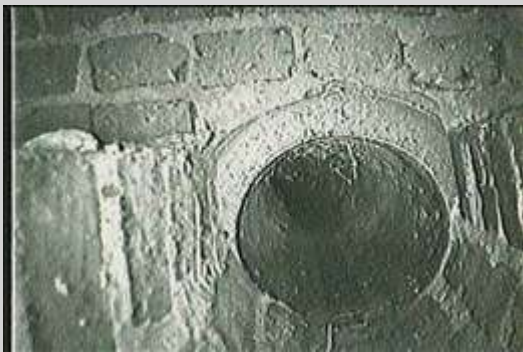
8 in. Circular Gravity Sewer Pipe Out @ 12 O'Clock

Infiltration: **None** Pipe Seal Cond: **Roots**

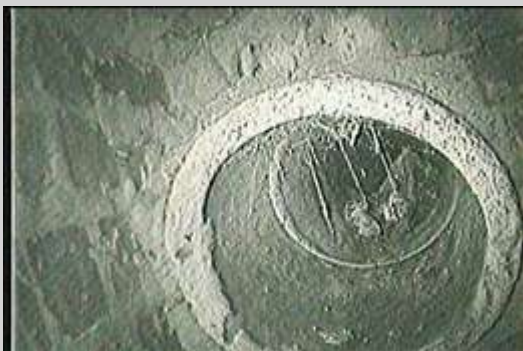
8 in. Circular Gravity Sewer Pipe In @ 7 O'Clock

Infiltration: **Evidence** Pipe Seal Cond: **Roots**

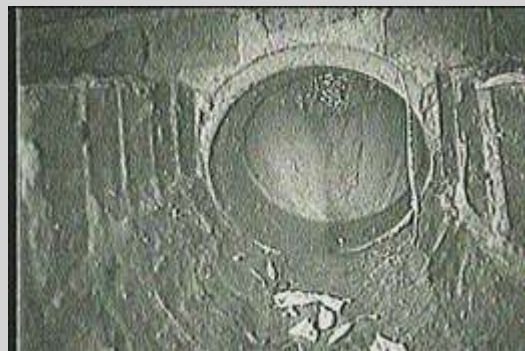
Drop In @ 7 O'Clock

Drop: **Outside** Rod and Bar

Drop Condition: **Open**
